33a Brocketsbrae Road,
Lesmahagow,
LANARK,
ML11 9PT

Home Report

Single Survey

Property Address	33a Brocketsbrae Road, Lesmahagow, LANARK, ML11 9PT
Reference	1571735
Customer Name	Elsbeth Struthers
Date of Inspection	11th May 2026
Surveyor's name, qualifications and office	Martin Fleming DM Hall LLP Chartered Surveyors Unit 3, Cadzow Park 82 Muir Street Hamilton ML3 6BJ Tel: 01698 284939 email: hamiltonresidential@dmhall.co.uk
Prepared By	DM Hall LLP

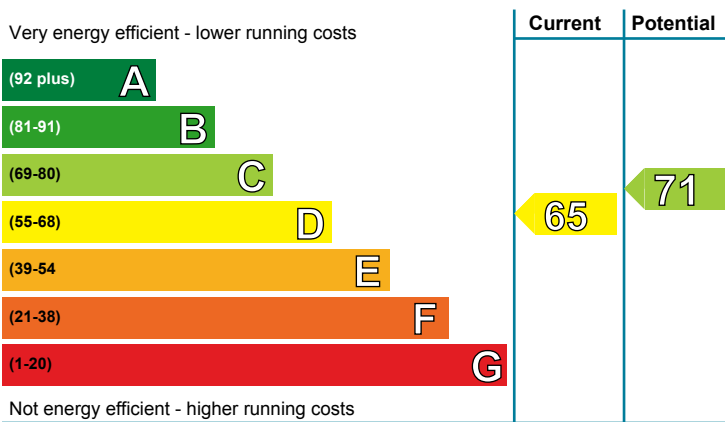
Energy Efficiency Rating

This graph shows the current efficiency of your home, taking into account both energy efficiency and fuel costs. The higher this rating, the lower your fuel bills are likely to be.

Your current rating is **band D (65)**. The average rating for EPCs in Scotland is **band D (61)**.

The potential rating shows the effect of undertaking all of the improvement measures listed within your recommendations report.

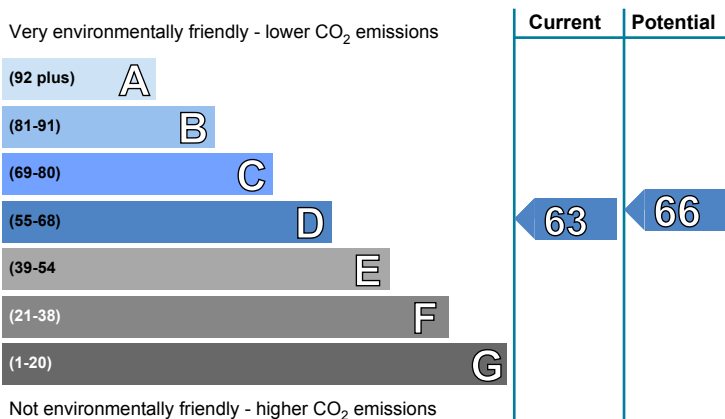
Environmental Impact (CO₂) Rating

This graph shows the effect of your home on the environment in terms of carbon dioxide (CO₂) emissions. The higher the rating, the less impact it has on the environment.
